# From Research to Practice: Field Testing Mortars for Cathodic Protection

Karla Hornbostel Statens vegvesen, Norway

Betonreparationsdagen, Comwell Kolding, Kolding

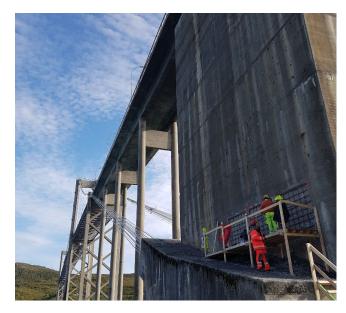
North side with mechanical repair

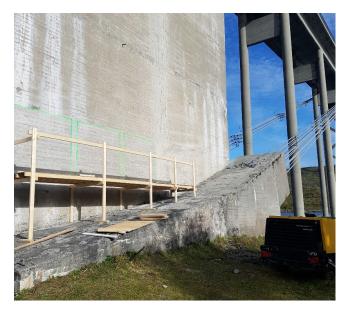
**South Side** without mechanical repair

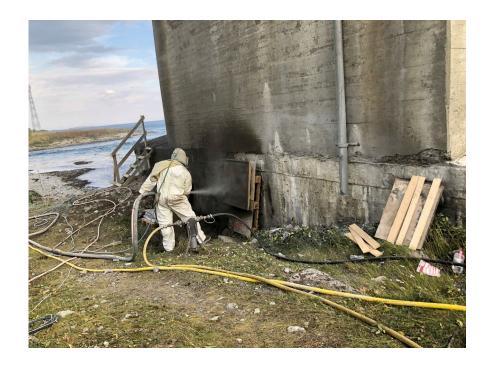
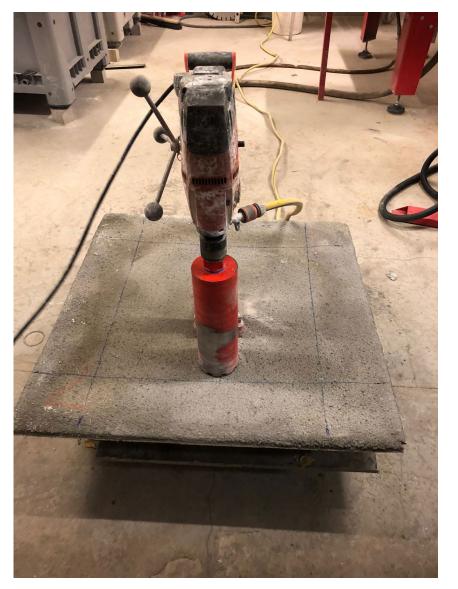
- ▶ Laboratory specimens produced in the field
- Sprayed mortar and core drilling

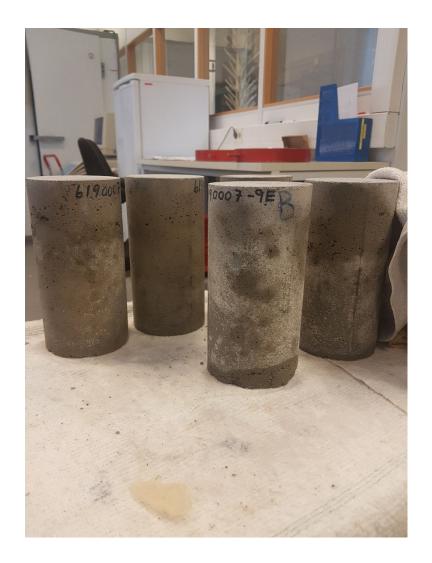
- ▶ Laboratory specimens produced in the laboratory
- ▶ Low and high water content

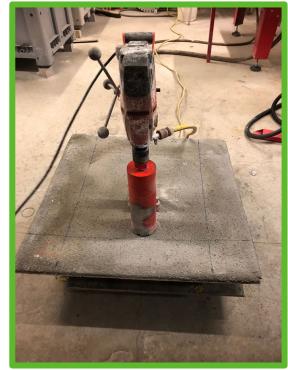
I. Electrical resistance testing – production of specimens

- Electrical resistance of dry spray mortars should be documented on sprayed samples.
- Electrical resistance of dry spray mortars increases over several months after spraying.
- High variability of resistivity between products.
